Bosch hydraulic cylinder inlet ports seals replacement

Ivan Ruiz – December 2017

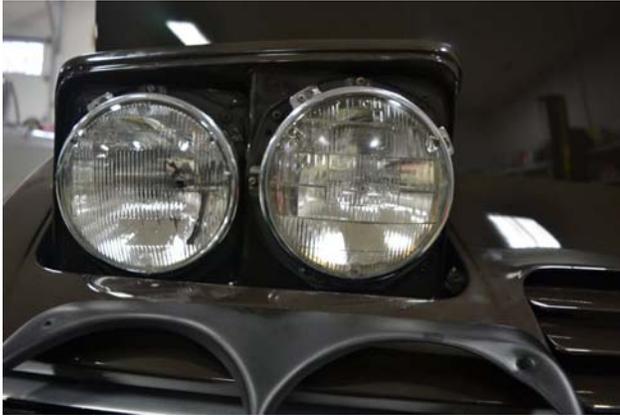
- First, raise the headlights
- Remove 4 screws that hold the trim in front of the headlights, remove the trim

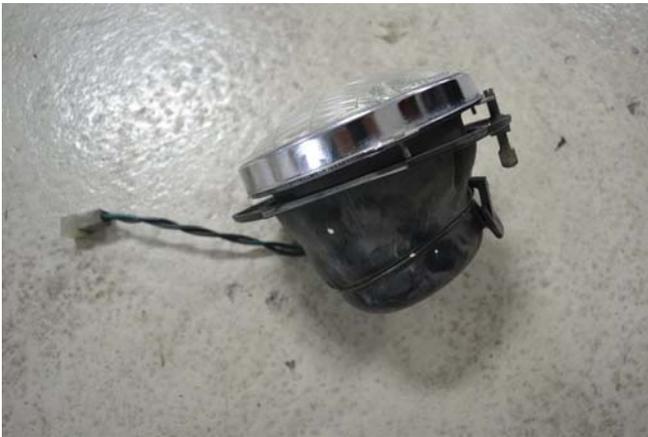
- Remove the three screws that hold the lamp making sure not to disturb the adjustment screws. Unplug the connector and remove the lamp.

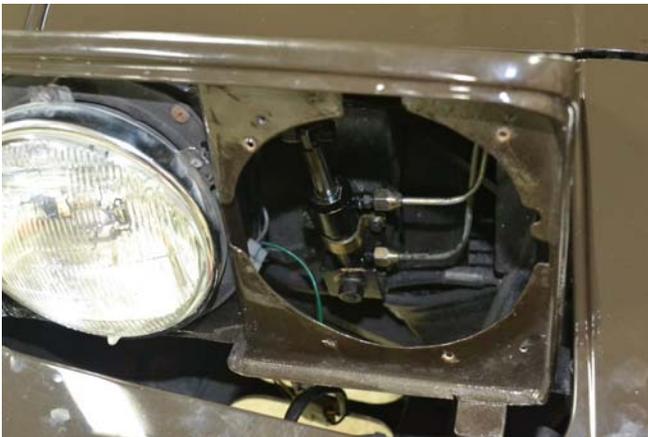
- The cylinder is now accessible. If you have very large hands you may want to remove the other lamp as it is very easy to do.

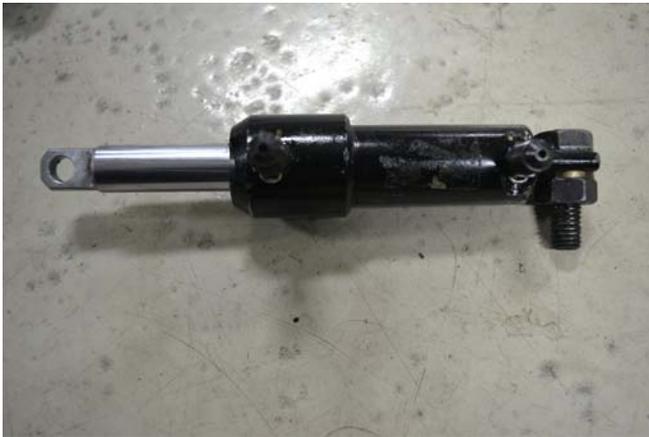
- Use 17mm socket to remove the large nut at the bottom of the cylinder
- Use a 8mm socket to remove the two bolts that hold the U shape bracket
- The cylinder can now be removed. Some wiggling is required but it will eventually come out.

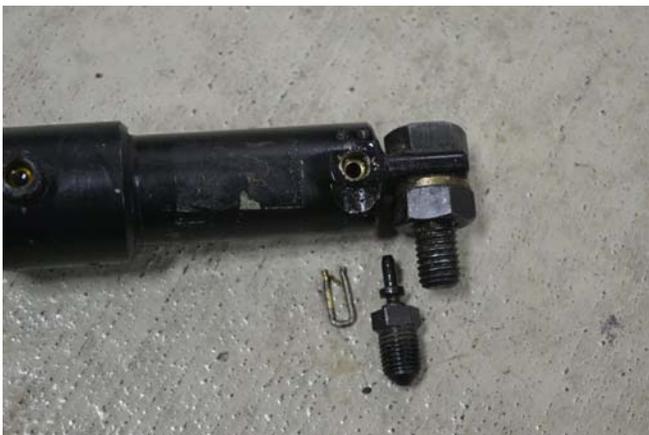
- Remove the clips that hold the two port adapters and remove the adapters

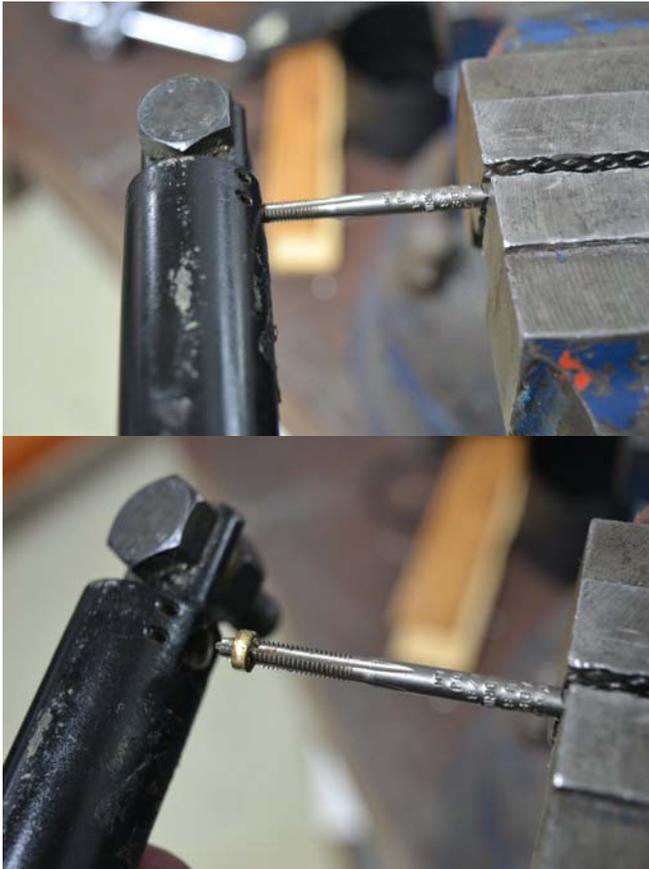
- Inside the ports you will notice a brass retainer. Under this retainer is the rubber seal that needs to be replaced.
- Use a 4mm tap to thread the hole inside the retainer
- Once threaded and secure, put the other end of the tap on a vice and extract the retainer using a small hammer on the cylinder

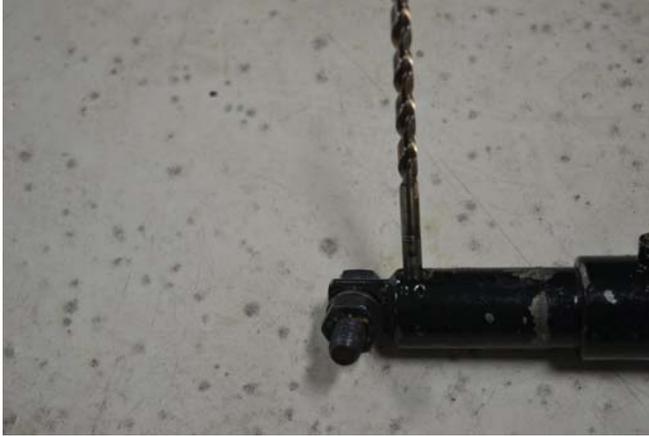
- Using a very small screwdriver remove the rubber seal which will be located inside the port hole.
- Use a cotton swab (Q-tip) to clean both ports as there will most likely be brass metal fragments.
- Lubricate the ports with LHM and insert the new rubber seals
- I like using the back end of a drill bit to push the seal all the way down the hole. Make sure the seal lays down correctly.

- You can reuse the brass retainer as the threads will not affect the seal
- Place the retainer on the hole and slightly tap it until it is flush
- Use the adapter and a non-metal hammer to drive the retainer down the hole. The adapter has a shoulder that will prevent the retainer from going too far inside the hole and damaging the seal.
- Put on the clips and the cylinder is ready to be reinstalled.
- Do not forget to remove the manual headlamp lift lock before you start the engine!
- Before reinstalling the lamp, operate the headlight lift switch several times and verify there are no leaks. I left the lamps out all night and verified there were no leaks the next morning.

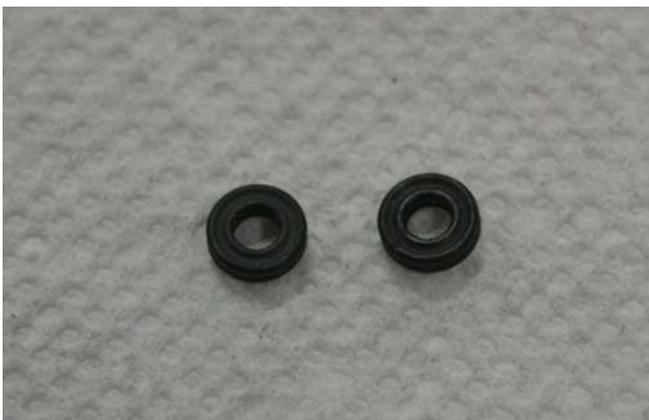
Notice that the seals are not just a regular o-ring

The only new parts that are needed for this repair are the rubber seals. MIE sells the seals and they are not expensive. Part number: MIE000337
<https://www.maseratinet.com/p-11226-port-seal-quad-ring.aspx>
